Musselshell BMPs

Abandoned Channels (Avulsions)

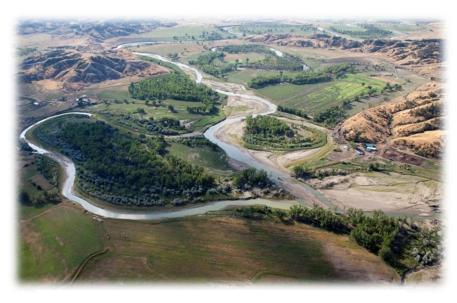
Figure 1. 2011 avulsion, Musselshell River.

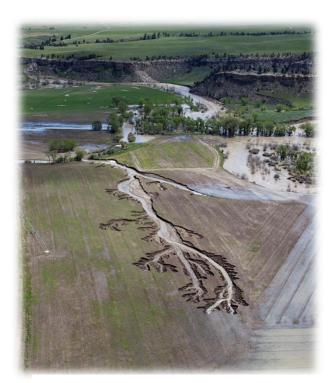
Figure 2. Upstream-migrating headcuts showing creation of avulsion path, 2011.

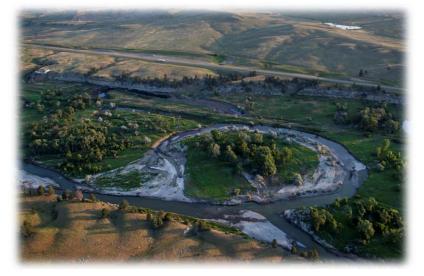
Figure 3. Meander cutoff formed by 2011 flood.

The most common form of an avulsion that occurred in 2011 is a bendway cutoff. This happens when a meander bend forms a new, shorter channel through it's core. This is a common, natural river process

that leaves floodplain swales known as oxbows. As they evolve, oxbows generally form first as open water wetlands, then continally fill in with fine sediment to become a low, arc-shaped floodplain swale/wetland. Meander cutoffs have posed problems for producers in the corridor, as the avulsions have commonly isolated land, eroded fields, and abandoned infrastructure (pump sites, diversions, bridges, etc.). As such, these sites have been comonly considered for reactivation; that is, putting the river back into its original pre-avulsion course.

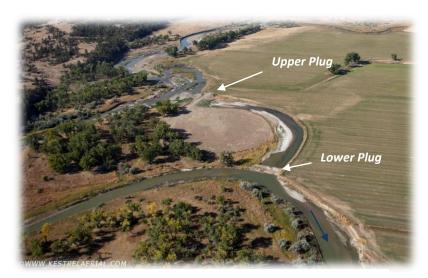
Figure 4. View upstream of plugged avulsion.

the avulsion with high plugs or comletely filling it, it can be designed to serve as a high flow channel that will contibute to groundwater recharge, water quality improvement, riparian renewal, floodwater storage, and floodplain protection. These benefits are all described in Section II of this BMP. Converting an avulsion to a higher flow feature requires the construction of a

stable grade control on the upstream end that is well-tied- in to the active streambanks, and

- has an elevation crest that is designed to overtop at a set flow. This necessarily requires significant hydrologic design efforts, including an evaluation of the stage/discharge relationship at the head of the avulsion. The downstream face of the grade control will require an armor treatment to prevent its failure due to overtopping scour and headcutting.
- b. Steep banks in the avulsion path can create problems for irrigation, cropping, and equipment access. Grading or shaping the banks of the avulsion to a slope of no steeper than 3H:1V will help stabilize those banks prone to collapse, and will help vegetation to establish.
- c. Planting the banks of the avulsion to native species will accelerate its conversion to a high flow, vegetated swale. Disturbed areas in avulsion paths should be carefully managed for noxious weeds.
