Riparian Protections

Applicability

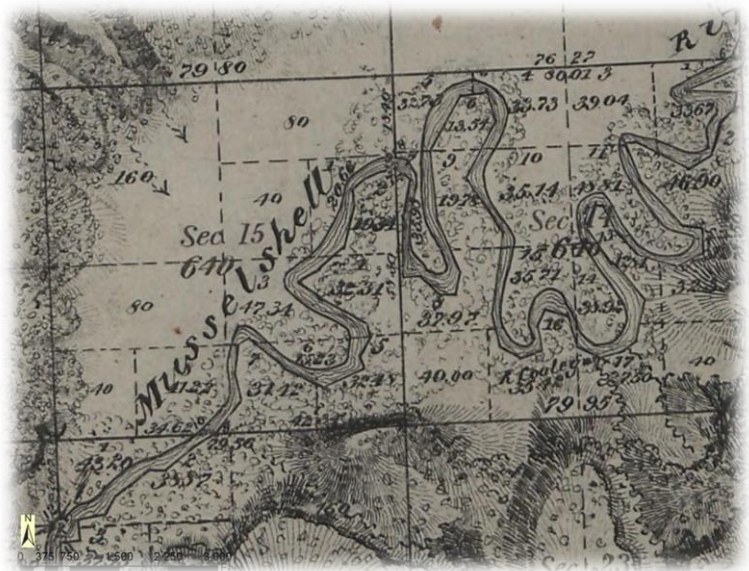
Figure 1. 1883 survey map of Musselshell Valley below Musselshell.

General Land Office (GLO) survey maps show that in 1883, the Musselshell River historically supported a wide berth of woody vegetation where irrigated fields exist today. The floodplain clearing that has taken place over the past 130 years has reduced the ability of the river corridor to resist erosion and remain stable during floods. In 2011, flooding resulted in not only floodplain erosion, but also massive recruitment of riparian seedlings, both native and non-native. Cottonwood and willow germination was extensive throughout the river corridor, concentrating on bare sand, silt, and gravel deposits. Seedlings took hold in near-channel environments such as point bars, within abandoned channels, and on the floodplain throughout pastures and irrigated fields. Post-flood NRCS monitoring indicated that in places, up to 129,000 cottonwood seedlings and 17,000 willow seedlings had established right after the flood.

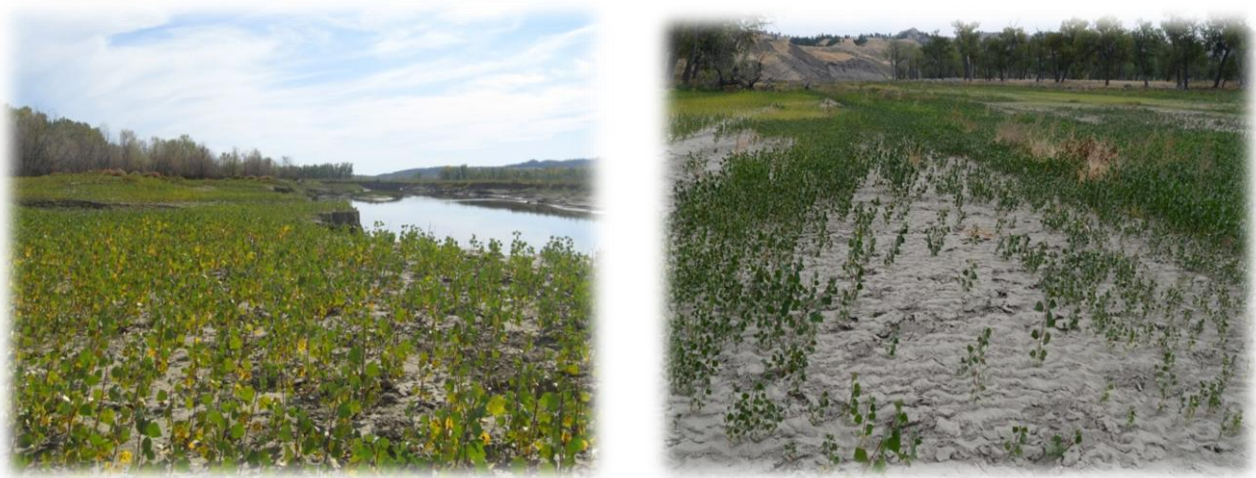
Figure 2. 2011 Seedlings in abandoned channels and on floodplain.

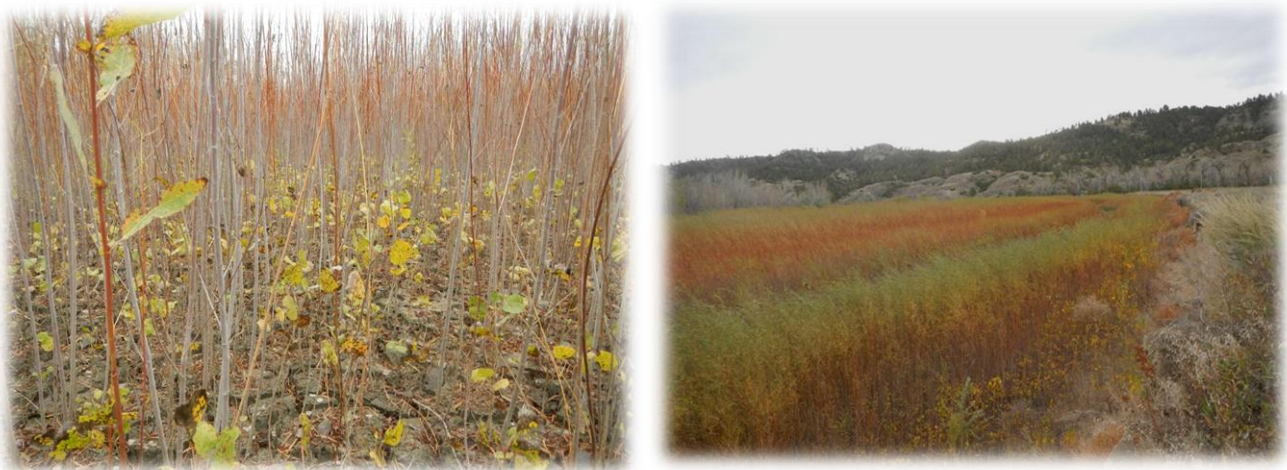
Figure 2. Cottonwood and willow growth in 2011 abandoned channel.

Abandoned channels maintain depressions that provide riparian vegetation easy access to shallow groundwater. Some of the most rapid and dense riparian recovery following the 2011 flood has been in such channels. Survival rates are high, the vegetation is dense, and the land is not conducive to crop production. These areas are recommended for active riparian protections through carefully managed land uses, especially short-term riparian fencing and/or long-term grazing systems.

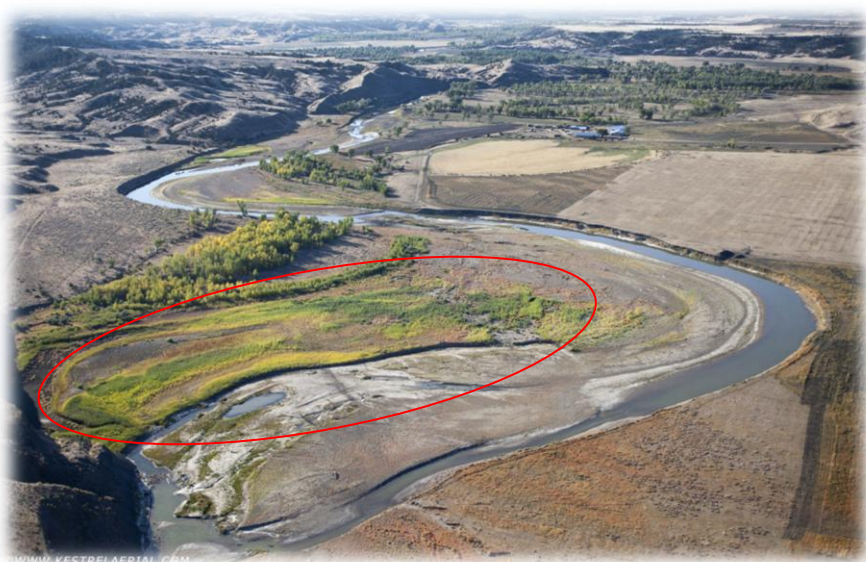
Figure 3. Example of channel margin area supporting new woody riparian growth.

Many of the 2011 seedlings established on a high floodplain surface that is typically in crop production. These areas, which are well-suited to flood or sprinkler irrigation, cultivation, and forage grazing by livestock and wildlife, will probably support some riparian trees in the long-term without concerted management, just by virtue of the sheer number of seedlings present. In contrast, areas within the active channel support some dense seedlings, but these areas will be prone to future scour by winter ice, summer thunderstorms, or spring runoff. Although the vegetation in the active channel is vulnerable, there may be significant opportunity to manage land uses to optimize riparian recovery in slightly higher areas which can be described as the “low floodplain”. These would be near-channel areas that are above the most severe influences of winter ice and spring runoff, but close enough to the channel to provide shallow groundwater access and some river disturbance. In general, these areas are between area wetted by the typical spring runoff (~2-year event) and the ~5-year flood. Most of this ground would be within the overall channel cross section that enlarged during the 2011 flood, and has remained several feet above the main channel. These near channel areas are where most seedlings typically establish, hence require special attention with respect to riparian protections.
